Condenser Performance Monitoring and Cleaning

John V. Walden
Presented by: Joseph P. Simpson
Rochester Gas & Electric Corporation

CONDENSER PERFORMANCE MONITORING AND CLEANING

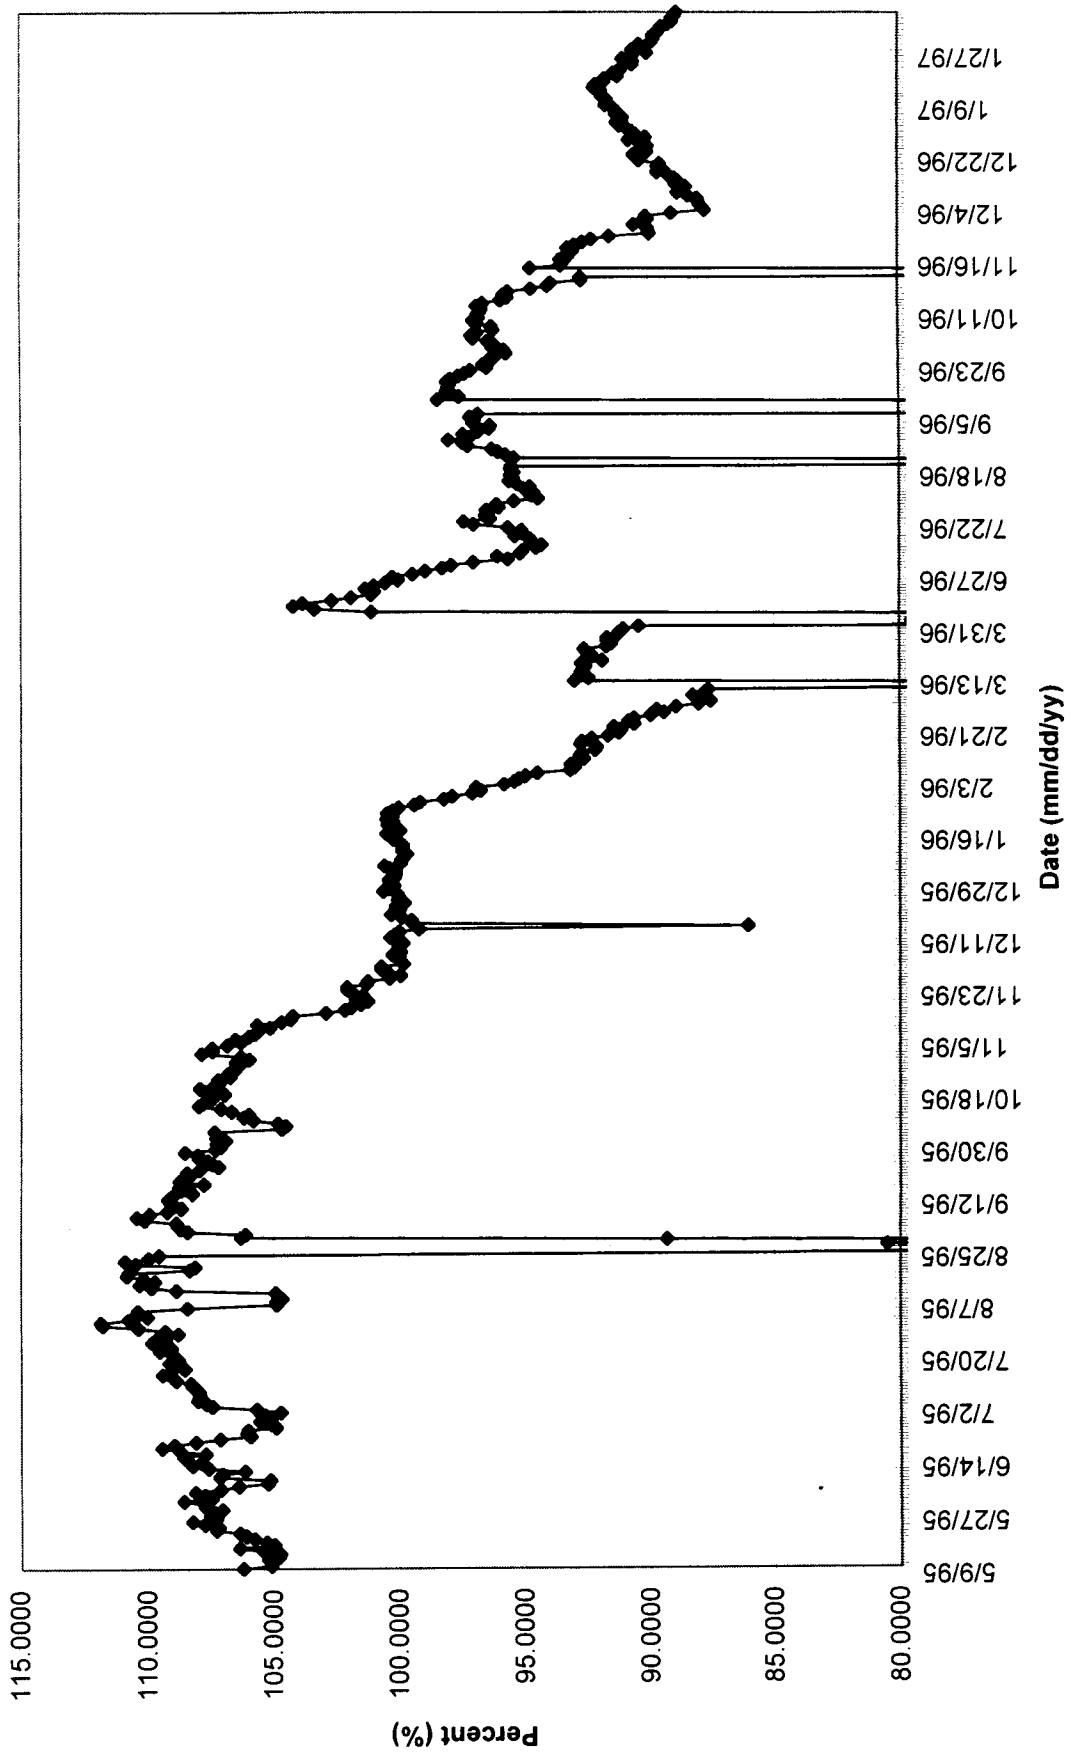
Fig. 1

Clean, baseline data from when the condenser was retubed was input into the spreadsheet. Attachment B, condenser performance factor graph, shows the dramatic decrease in performance starting in January 1996. Performance improved to 94% after the tube cleaning in the spring of 1996. The quick drop in performance following the cleaning in June 1996 was attributed to the malfunction of the circulating water chlorination system. Once repaired, performance leveled out at 95% until November 1996 when chlorination was halted.

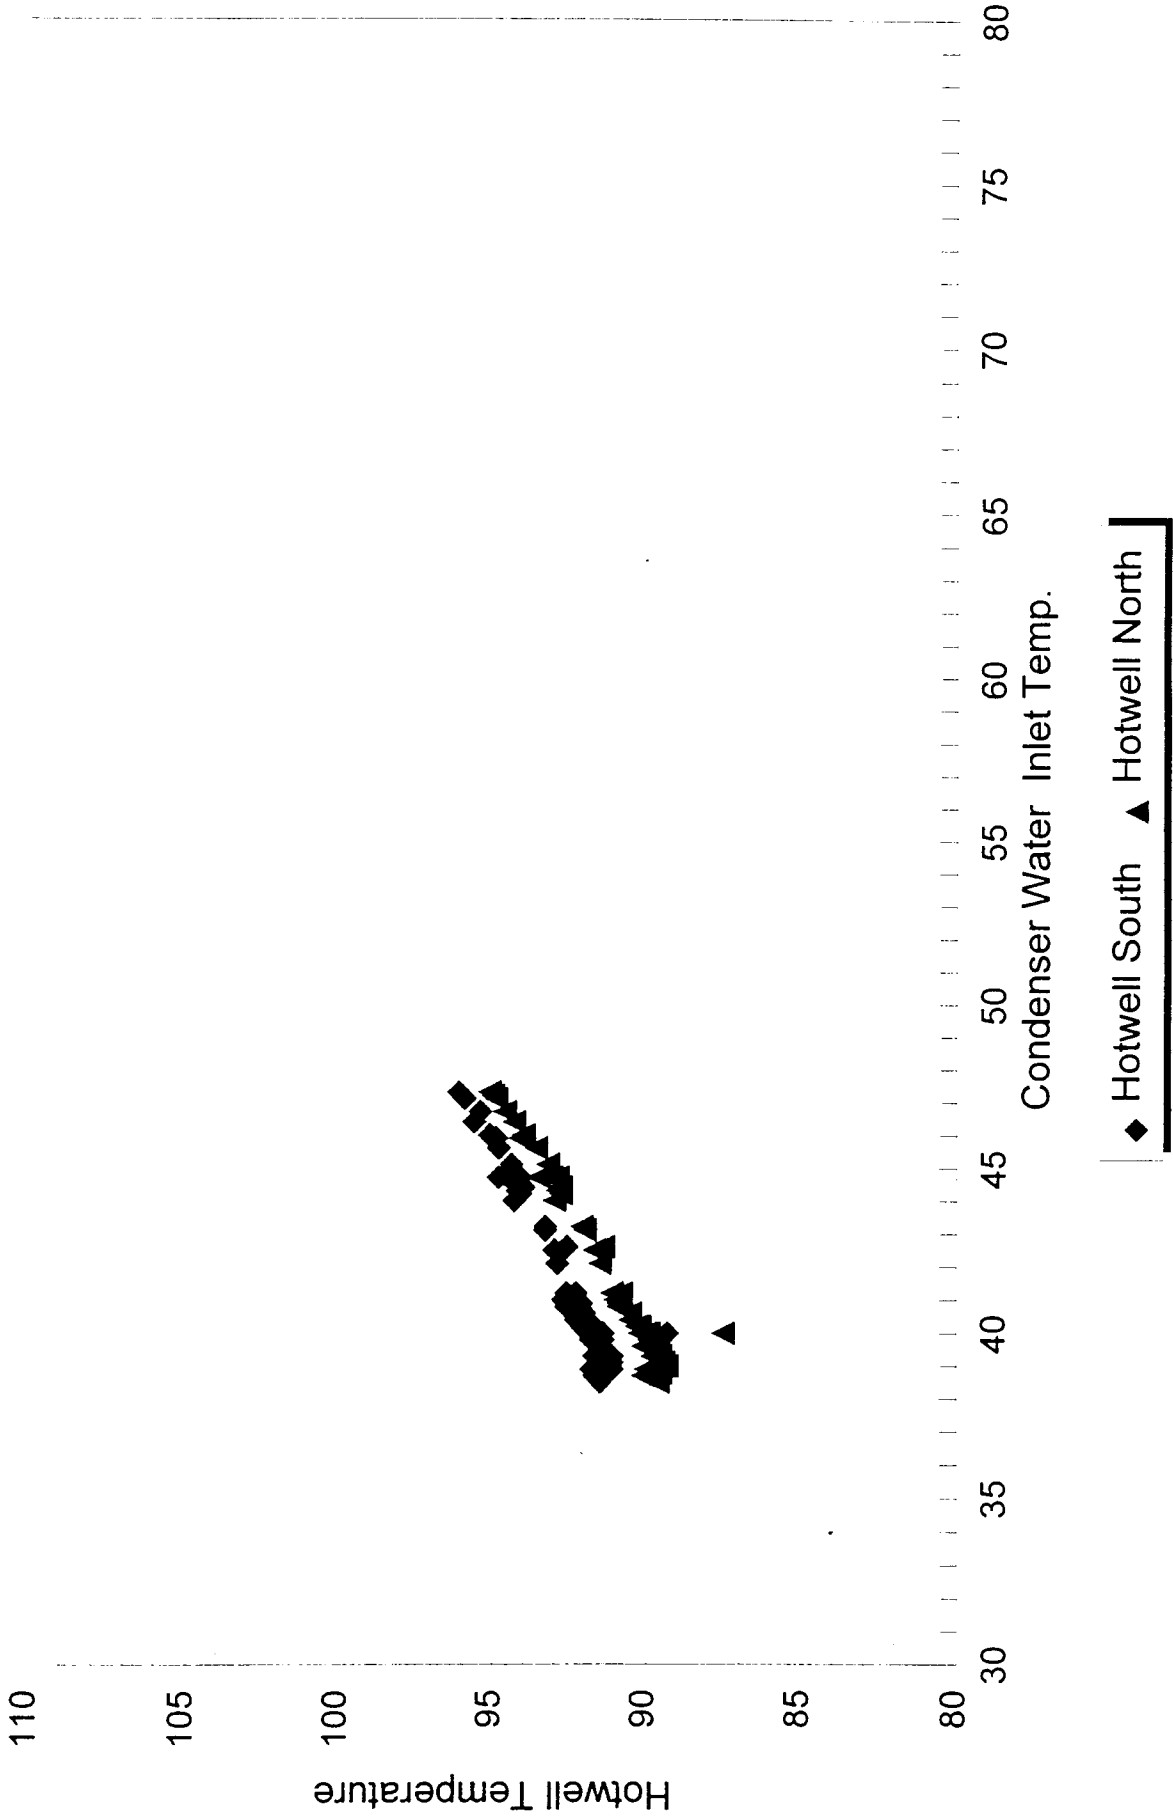
Hotwell Temp. vs. Circ. Water Temp.

Projections of the power loss due to condenser fouling were needed to perform a cost benefit analysis of the tube cleaning. The PEPSE thermal model of Ginna was used to generate the graphs of hotwell temperatures and gross megawatt output vs. water box inlet temperatures at varying cleanliness levels (see Attachments C & D). The condenser was placed in the design mode in the model using the revised 1995 HEI calculations for 316 stainless steel. The curves matched well with the measured values and cleanliness calculations (see Attachments E & F). Cost projections showed that if condenser cleaning was postponed until the fall refueling outage, the company would lose over \$300,000 worth of generation. Projected downpower and tube cleaning expenses were estimated to be slightly over \$200,000.

Precleaning at 78% Cleanliness

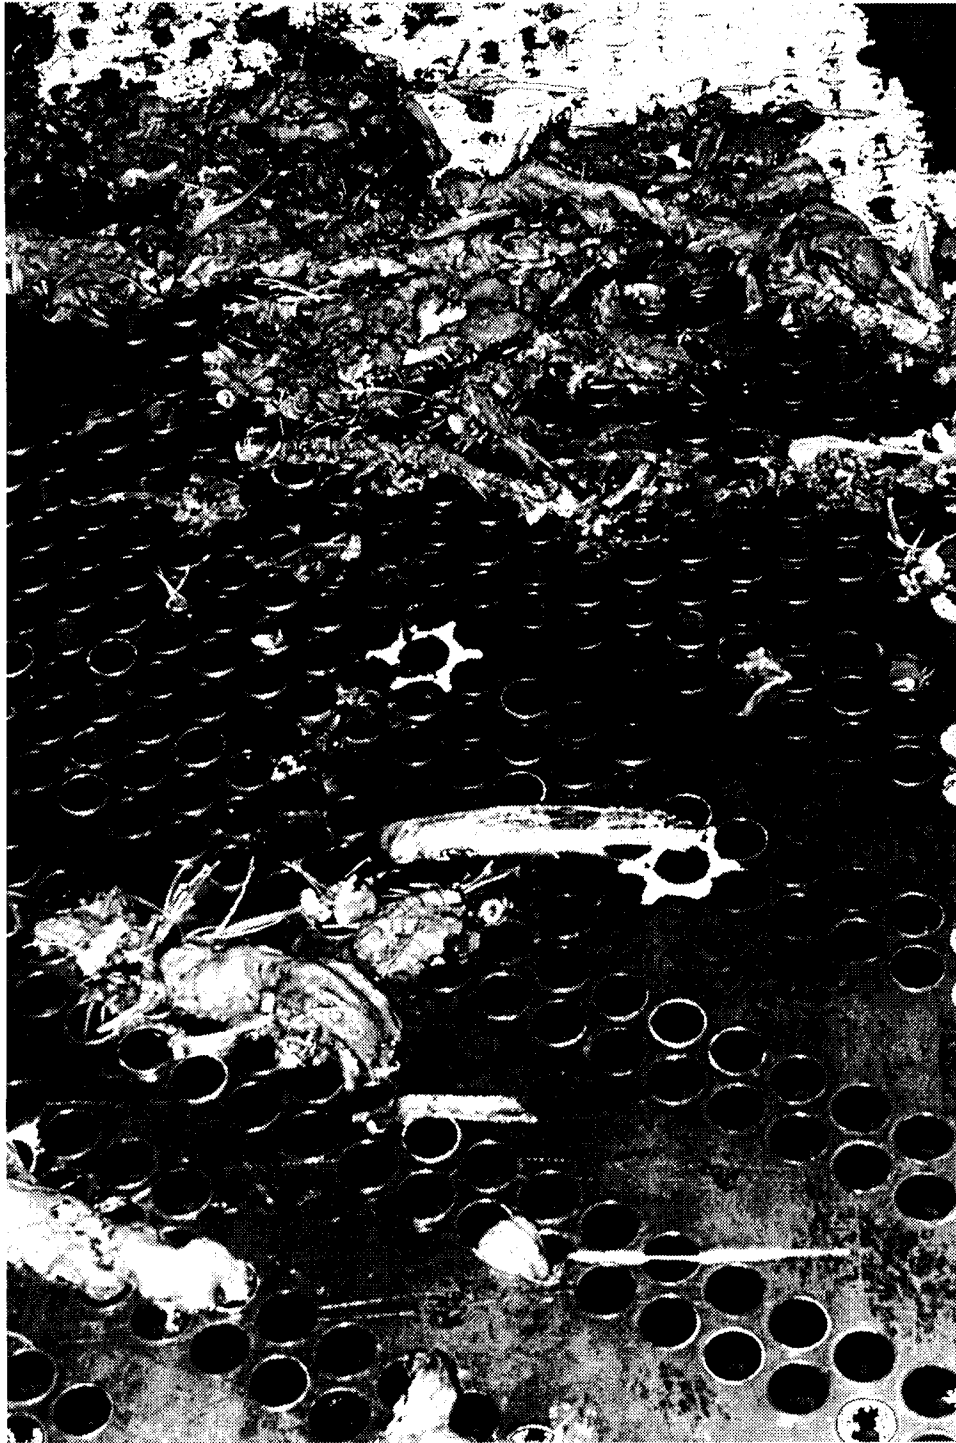
1A2 Condenser Inlet Tube Sheet

The power reduction and isolation of condenser water boxes went smoothly on the morning of May 17. Upon opening of the water boxes, it was clear that the blockage of tubes by debris and dead fish was not the cause of the condenser problems. The worst blockage is shown in the attached photograph of the 1A2 tubesheet. The majority of the pictured material on the inlet tube sheet are fresh water eel remains which were accumulated over the twelve months of operation. The other inlet tube sheets had significantly fewer clogged tubes.

The large bits of eels and fish were removed and the tube sheet hydrolased using a high pressure wash. Working conditions inside the water box inlet were greatly improved by performing this initial cleaning. Small amounts of slime can be seen on the stainless steel tube sheet. Initial visual inspection of the first few inches of the condenser tubes showed little slime build up. Tube scrubbers were loaded into the inlet side while eddy current inspection of the tubes was attempted on the outlet side. Eddy current probes could not be pushed very far down the tubes due to the fouling. During the testing the previous year, the probes were passed down the full length of the tubes with difficulty before they were cleaned. This was a clear indication that the fouling was worse than the previous cycle, as indicated by performance monitoring.

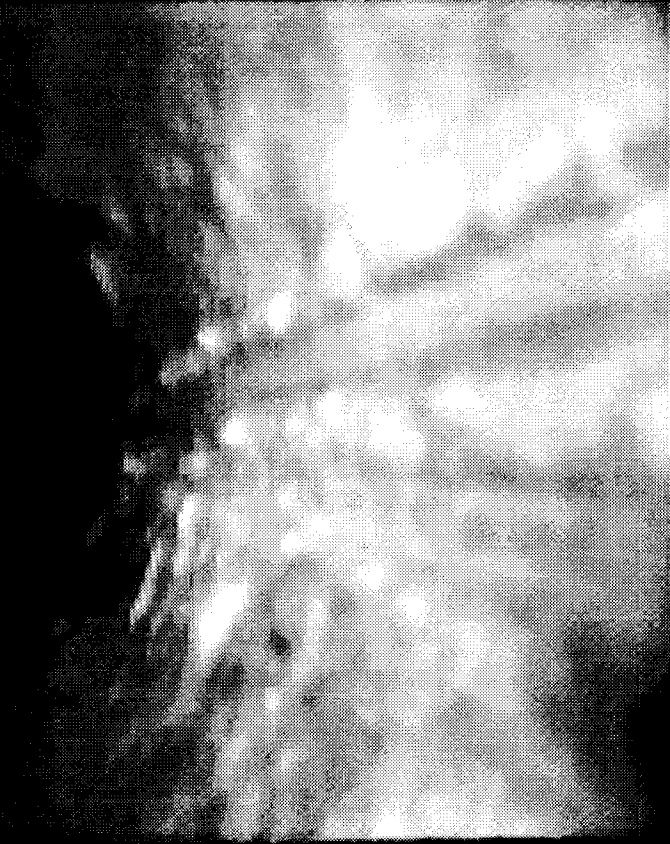
1B1 Outlet
Section #2
R-10 T-1

A camera inspection was performed inside the tubes to determine the extent of the fouling. As shown in the attached photographs, a thick layer of slime and silt was present. Tubes were then cleaned using the Goodway scrubbers. Samples of the fouling were collected for analysis. The attached photograph shows the inside surface of the cleaned tube. Large amounts of slime and silt were ejected out of the tubes as scrubbers shot out into the outlet water boxes. The duration of the cleaning process was thirty hours from the initial hold on the water box to release for the power increase.

Ginna Station Condenser
Prior to Cleaning

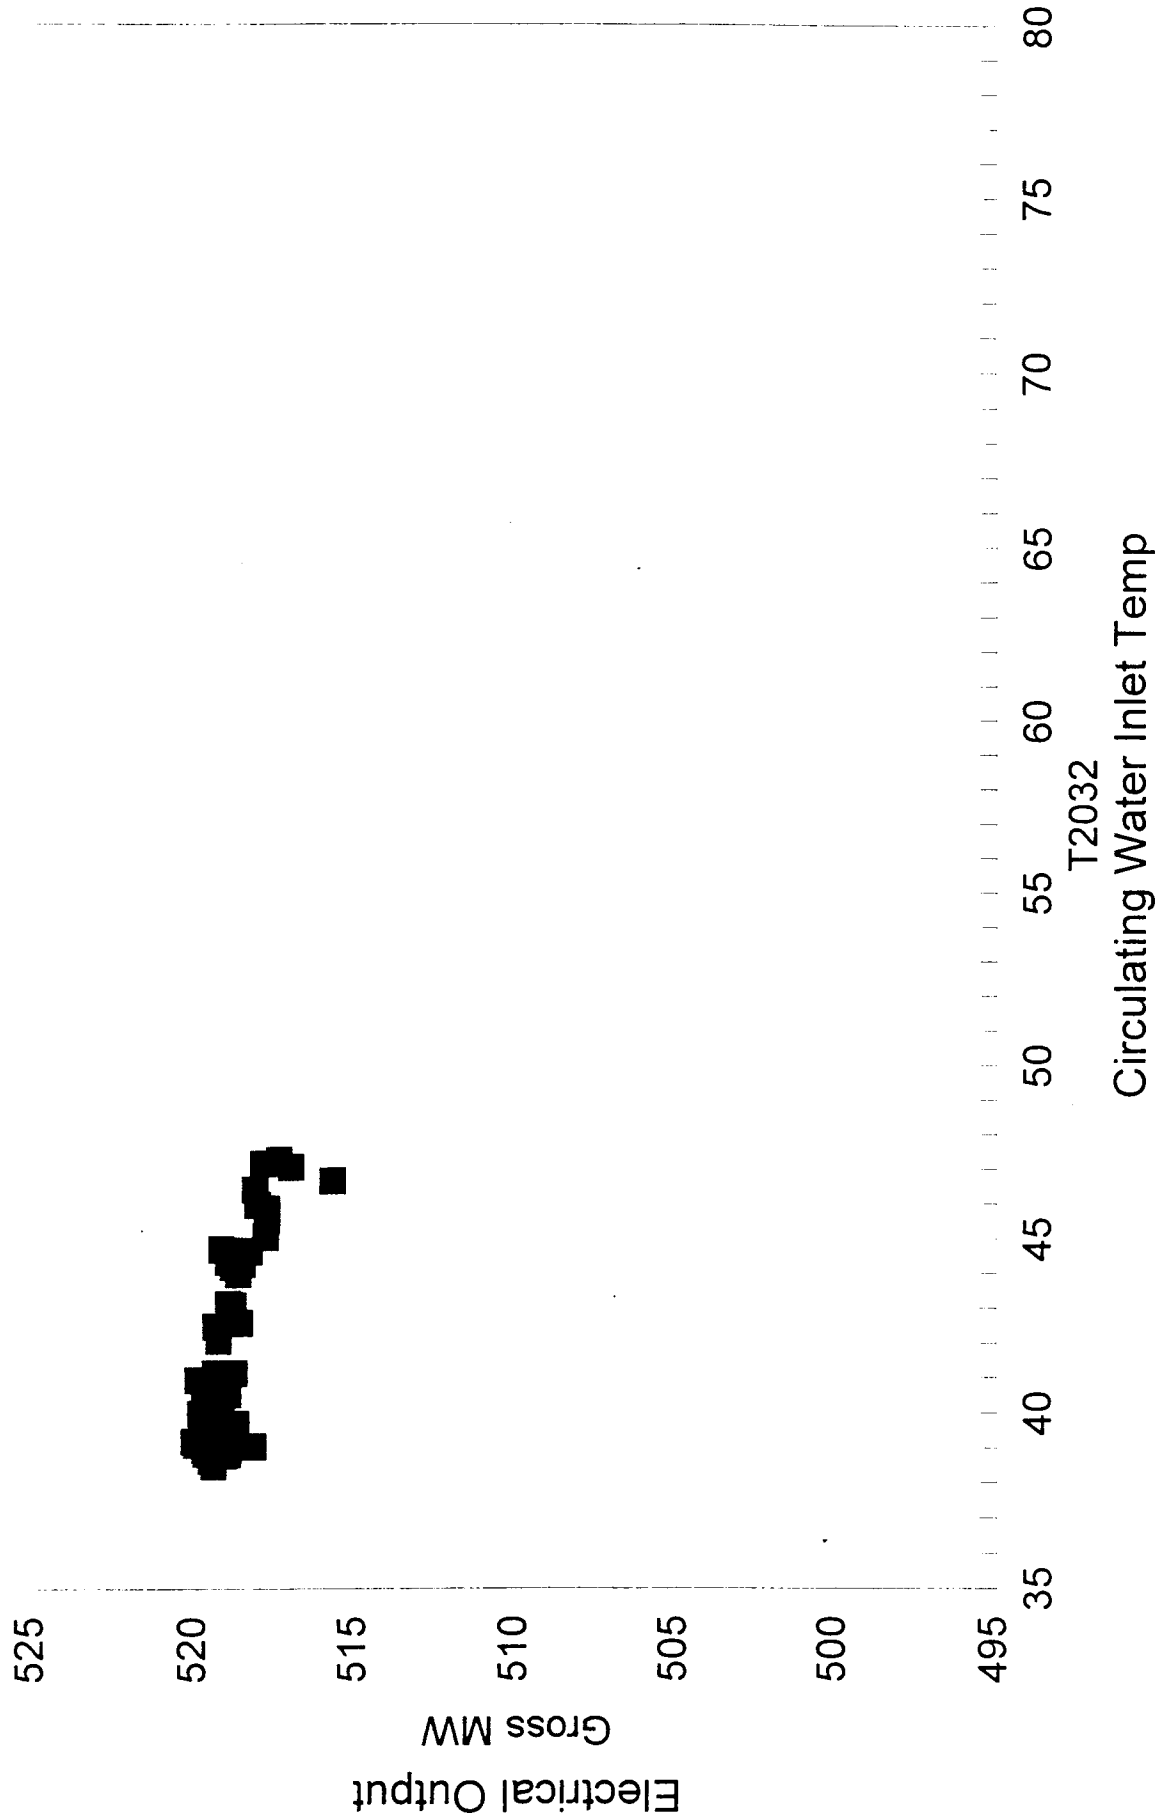
Gross Output vs. Circ. Water Temp.

Precleaning at 78% Cleanliness

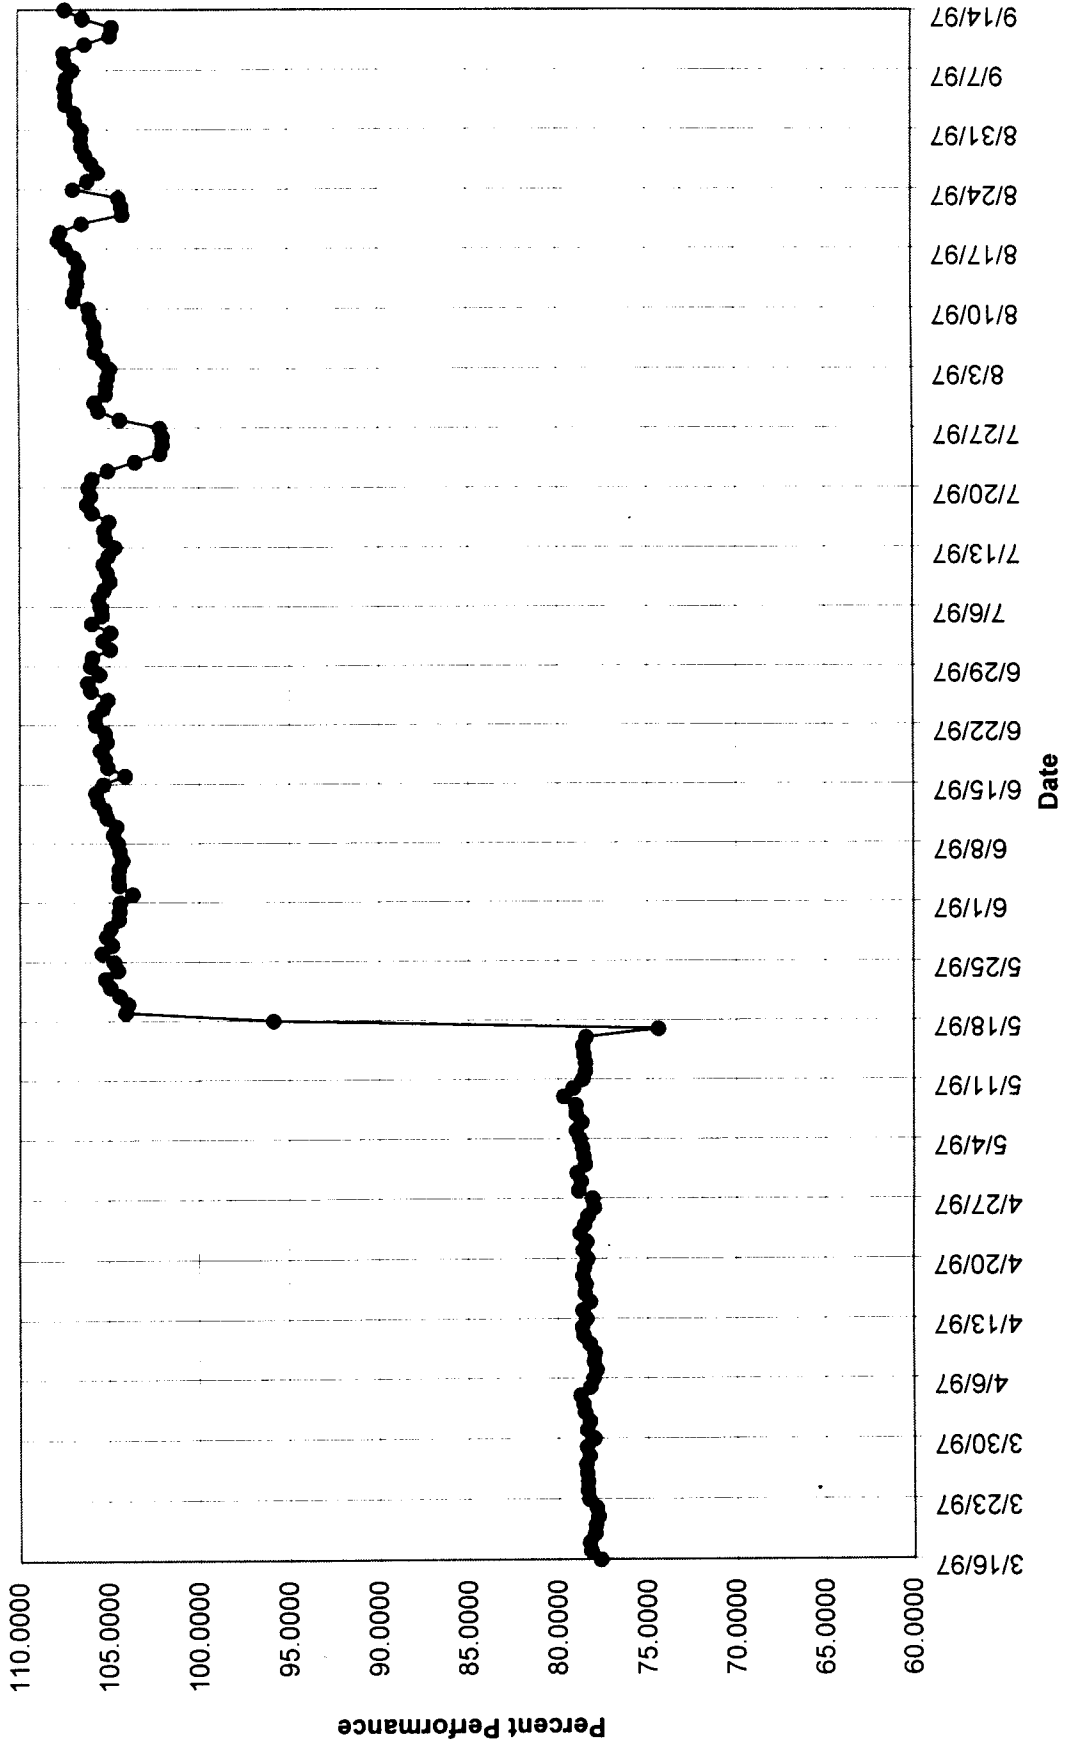
Condenser Performance

Improvements in condenser performance exceeded the levels used in the cost justification analysis. Condenser cleanliness increased to 105% instead of the projected 92%. Cost savings over the summer increased to over \$400,000. Daily chlorination at the allowable limits maintained condenser performance at 105%. A two week continuous chlorination at 0.1 ppm was performed in August. A two percent increase in performance was obtained as shown on the condenser performance graph, Attachment G. Graphs plotting hotwell temperatures and gross megawatt output vs. circulating water temperatures postcleaning are Attachments H & I. No cleaning of the condenser tubes is anticipated in the upcoming October refueling outage, saving \$16,000.
